## APPENDIX 15

### **RESTORATION IN ACTION: REDWOOD FOREST FOUNDATION INCORPORATED'S (RFFI'S) USAL REDWOOD FOREST (NORTHWEST CORNER OF MENDOCINO COUNTY)**

Presentation by Richard Gienger to the Pilot Project Working Group  
October 5, 2017

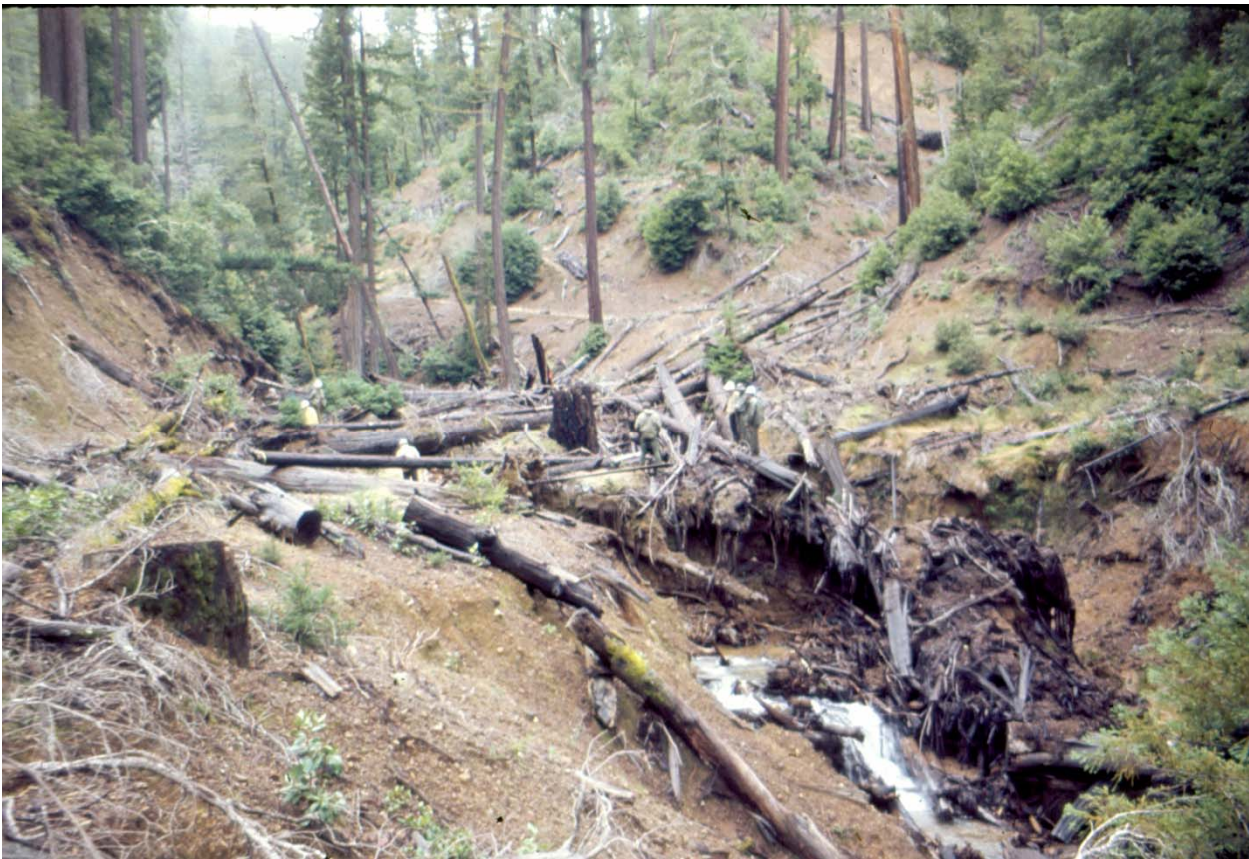
This photo, and the next one, are from the Standley Creek watershed in 1980 (Robert Ballard collection). They were taken during a North Coast Water Quality tour RE the need for Waste Discharge Requirements. I think it may have been the 1st North Coast instance of those requirements being imposed on timber operations. I had been under the impression that G-P et al. fought them off, but Robert Ballard told me that, indeed, Waste Discharge Requirements were applied. Frank Reichmuth [sp?], Al [?] Weller, and others from the NCRWQCB were involved. The first photo shows stripped and gouged area of the Standley Creek watershed -- harsh example of tractor logging/yarding after the modern Forest Practice Act & Rules took effect, but before significant changes had taken place to prevent such "legacy" damage.

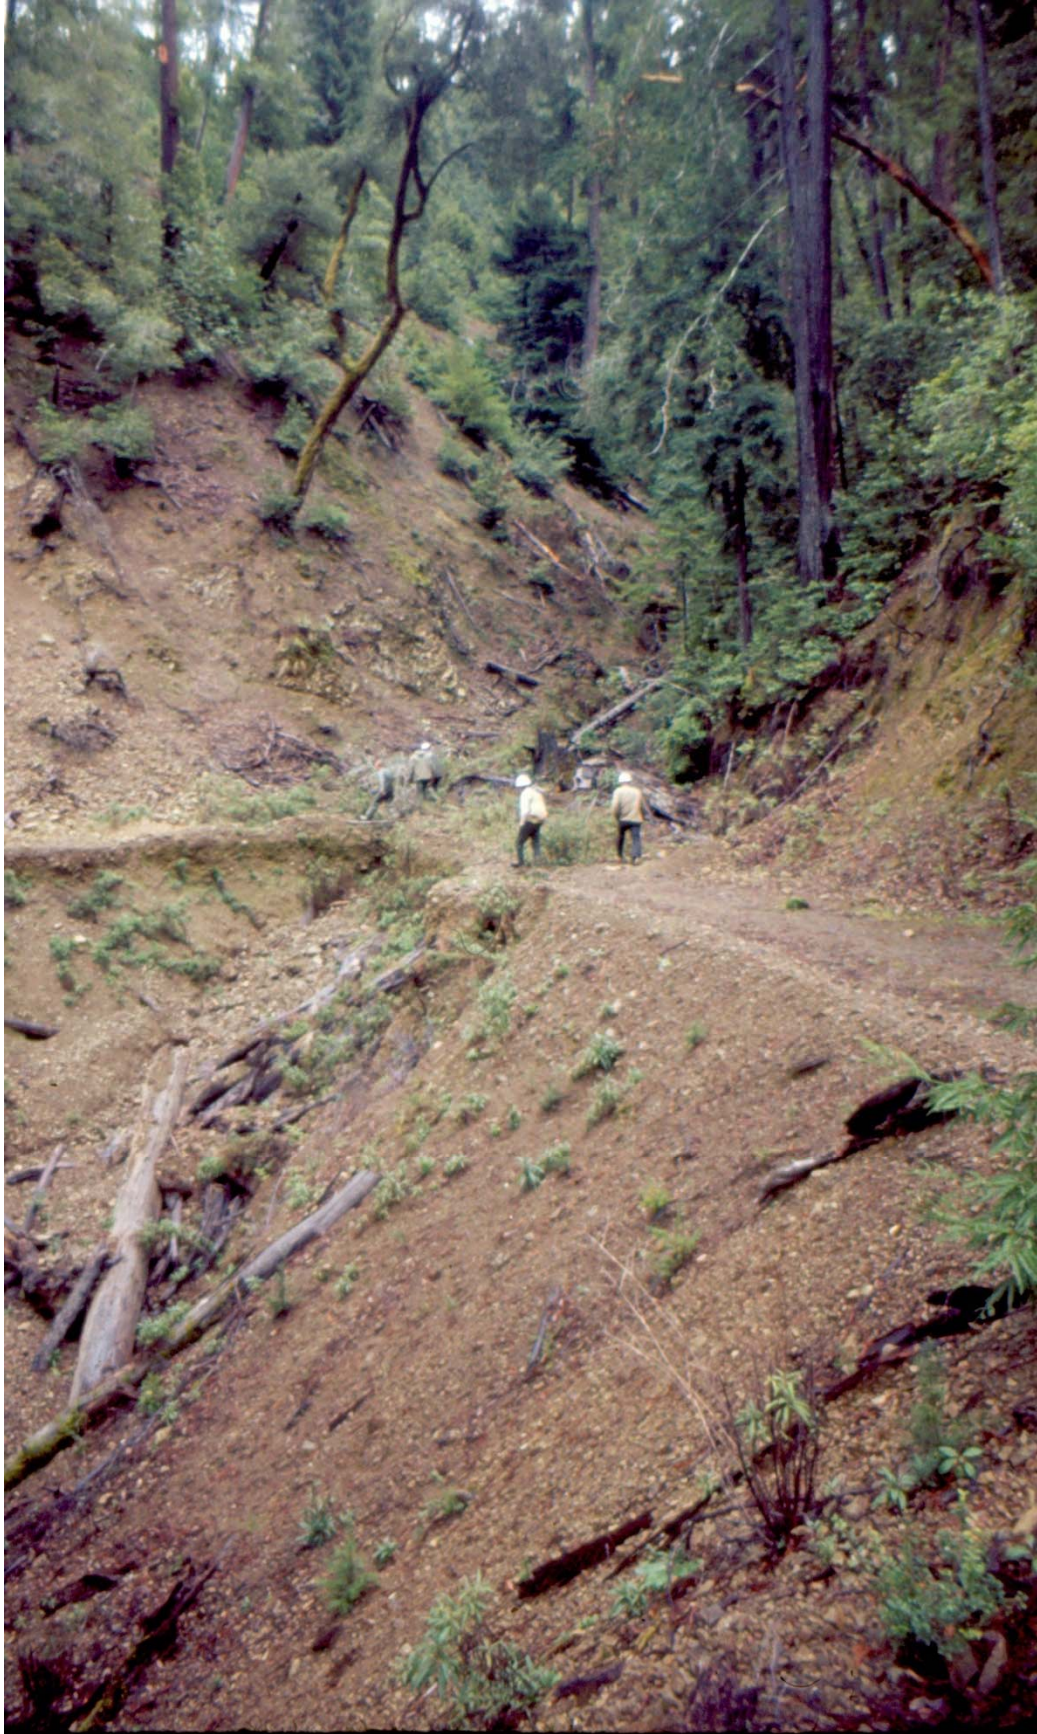
The second photo (previous page) shows a stream crossing that ignored basic engineering and treatment to prevent sedimentation and slope destabilization. These types of impacts often continue to affect slope stability and contribute to increased sedimentation -- even though the greatest impacts likely occurred in the years or decade immediately following the 1980 operation.

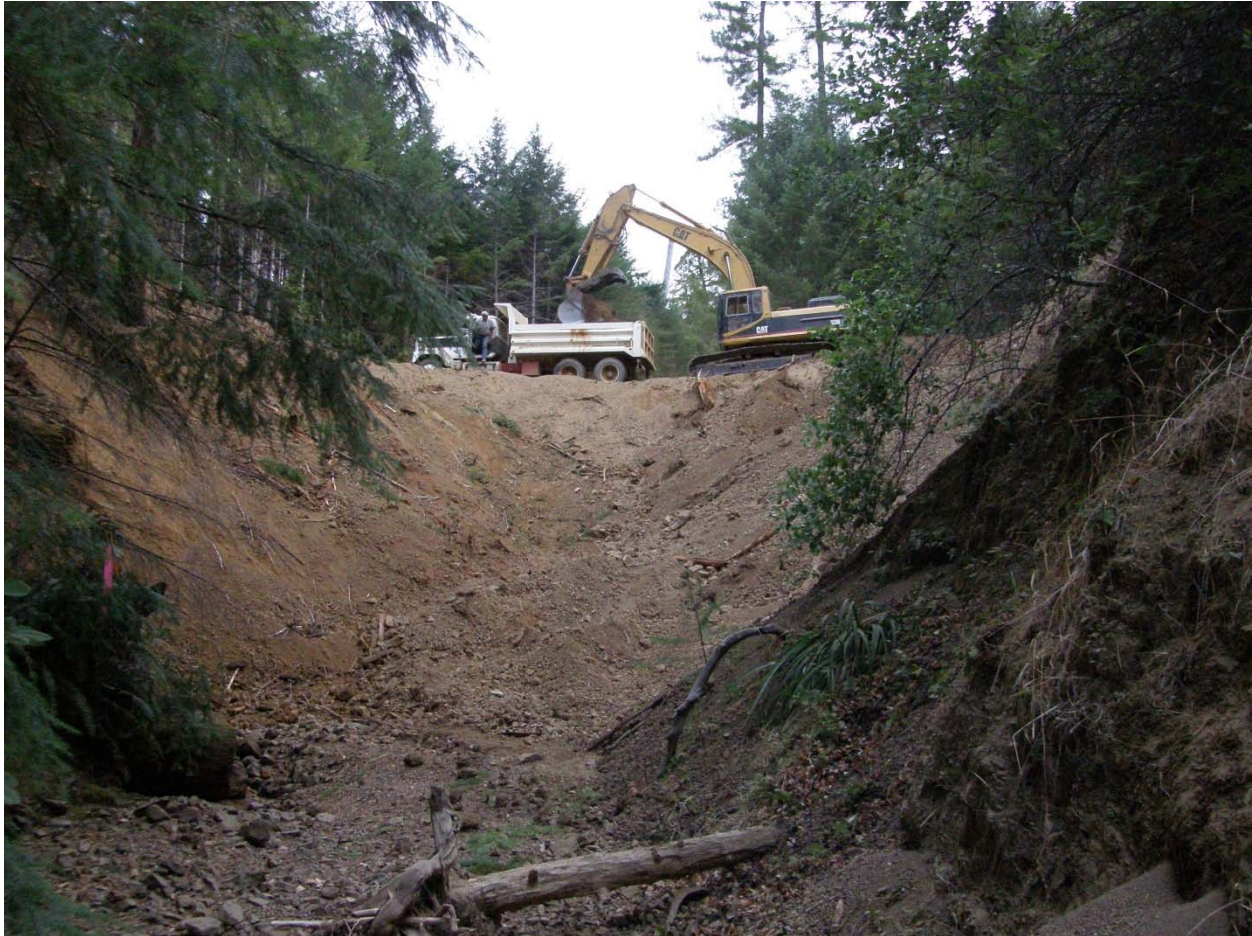
This photo shows the start of an excavation of a very large haul road crossing that buried the Clark Fork of Standley Creek. The view is looking upstream from below the huge fill. I think this was done in 2008 during one of the six phases of road decommissioning and/or upgrading in the Standley Creek watershed. The sixth phase was just completed this summer. The project was started during Campbell-Hawthorne ownership with a strong partnership of that company, the California Department of Fish & Game (now Fish & Wildlife), Pacific Watershed Associates (PWA), Trout Unlimited (TU), and others -- with RFFI/URF assuming ownership in 2007 and continuing the restoration partnership. Of special significance is the fact that the project addressed the adverse impacts and major necessary corrections for a logging road system in a whole CalWater 2.2 Planning Watershed. This is the scale that Cumulative Watershed Effects are almost always evaluated at in the THP process. Between 2 & 3 million dollars in grant funding and landowner cost share were expended to complete the six phases. This watershed and the extent of the hydrological damage are typical through most of north coastal California. Almost all these impacts resulted from the tractor logging/yarding starting with the ad valorem tax after WWII and continuing into the 1980s. It was the policy and law in California from 1946-1976 that landowners were taxed every year on their standing timber until they cut 70% of it. This was succeeded by a yield tax

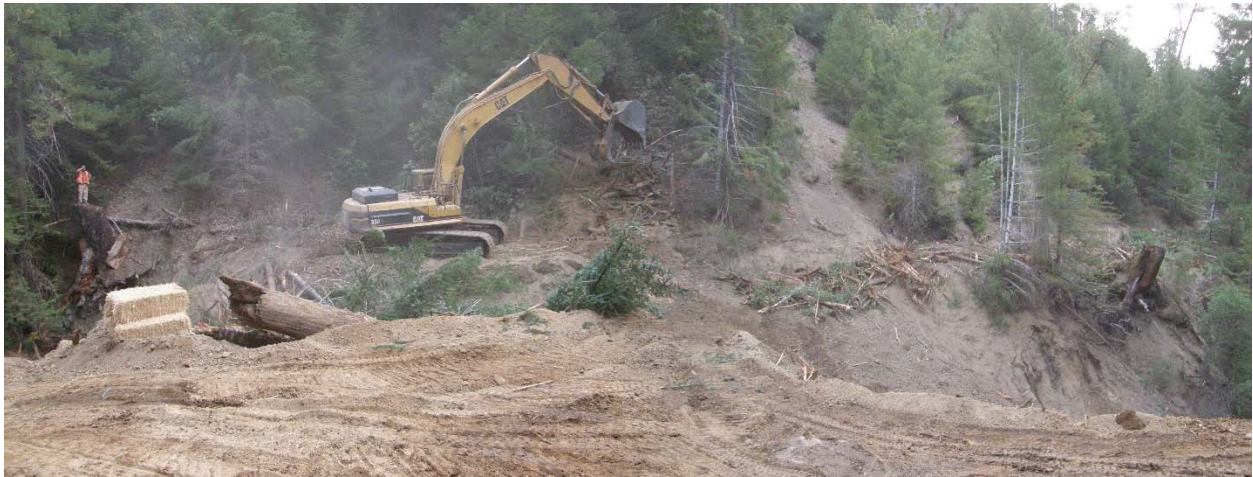
The photo above shows the continuing large excavation, looking approximately eastwards across the Clark Fork, which runs from North to South before joining Standley Creek. Standley Creek joins the South Fork Eel River across from Piercy. Note PWA's Tom Leroy standing on an old growth Redwood stump on the left side of the photo affording some scale and perspective of the site and the work. Almost all of the excavated material was hauled by dump truck to a safe and stable location outside of inner gorges and steep slopes.

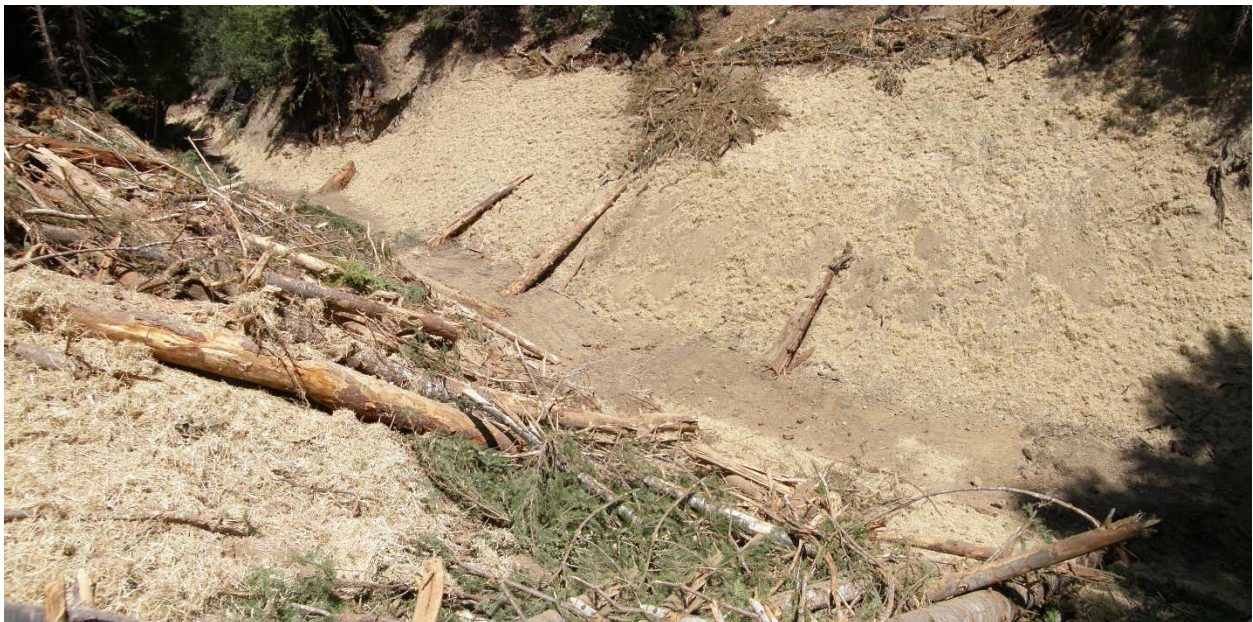
This photo shows a major section of the excavated channel with straw mulching and 'herringbone' placed large logs.

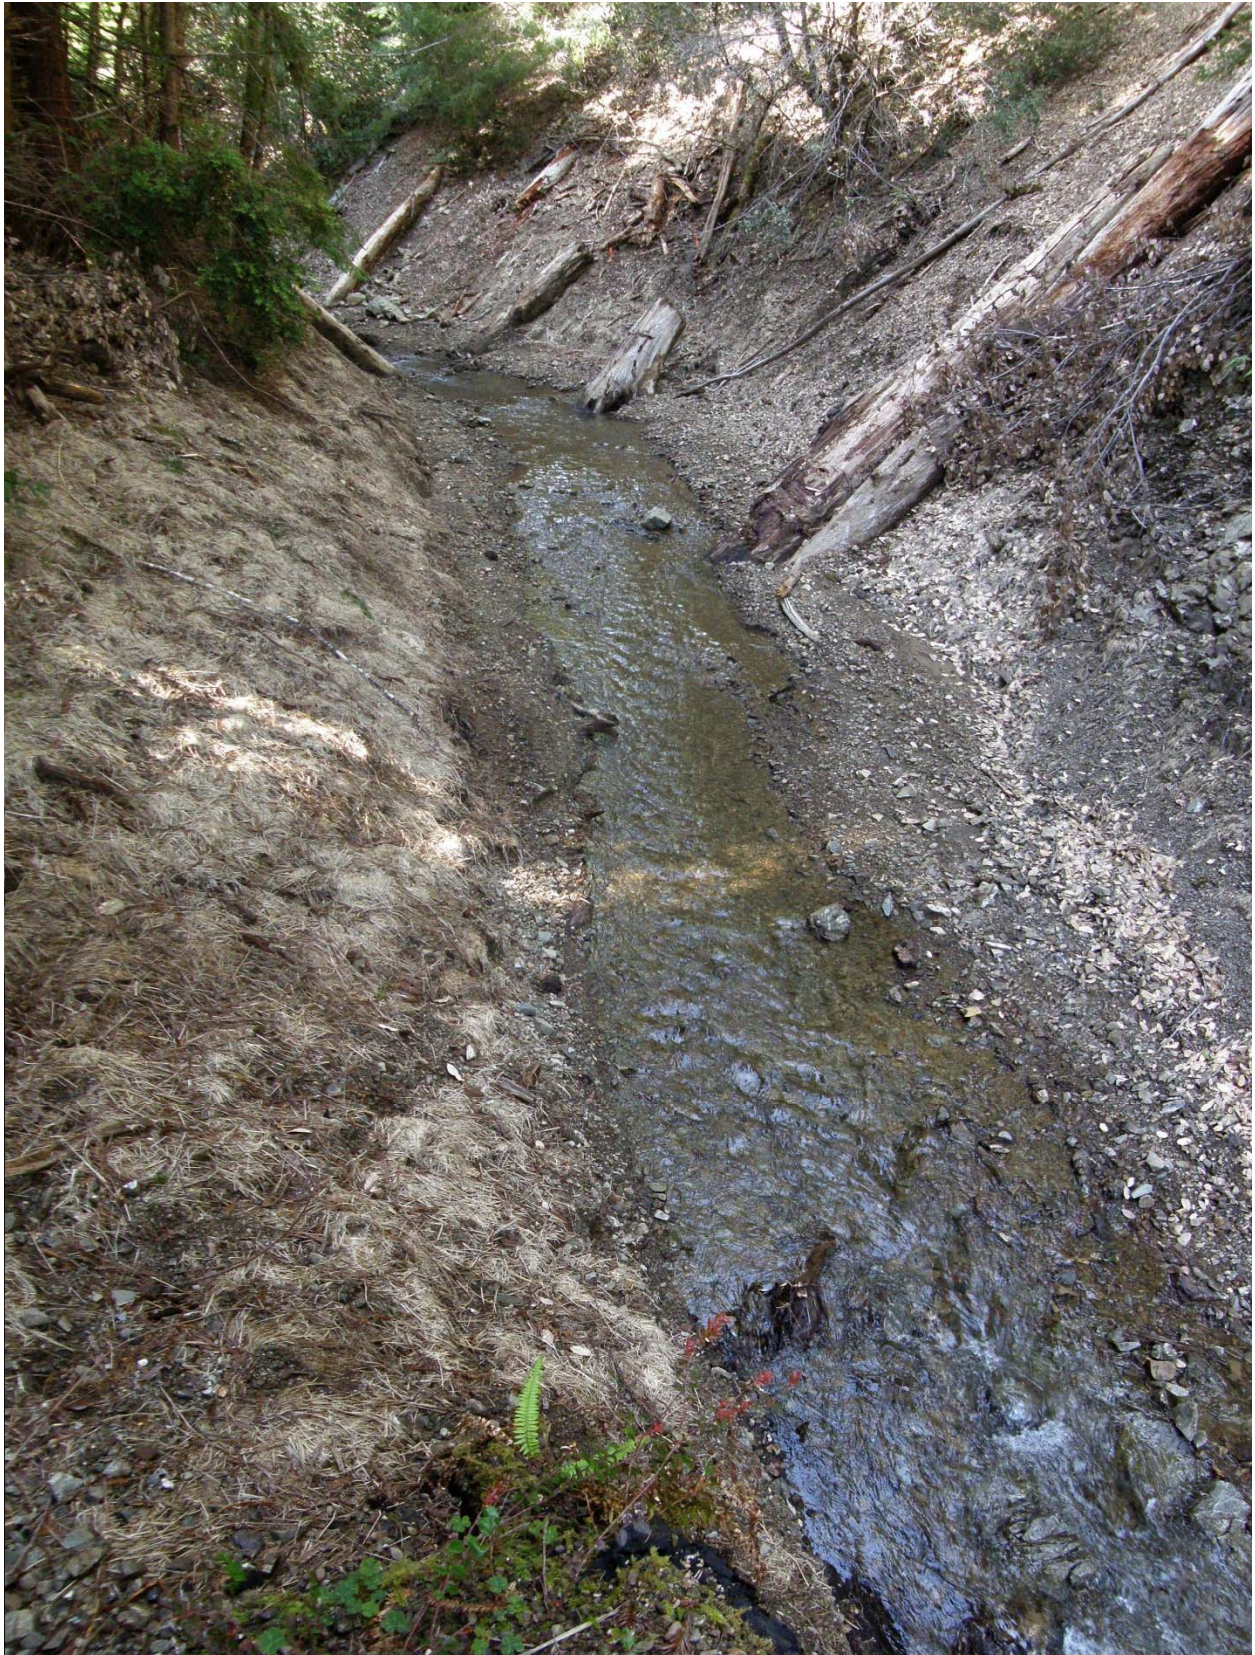
The photo on the previous page was taken from the old growth stump that Tom Leroy was on -- looking upstream during the first winter following excavation. The excavation was carefully done to get to the original channel-bed as close as possible and to reduce excessive "adjustments" causing streamside and riparian erosion -- and promote natural recovery.

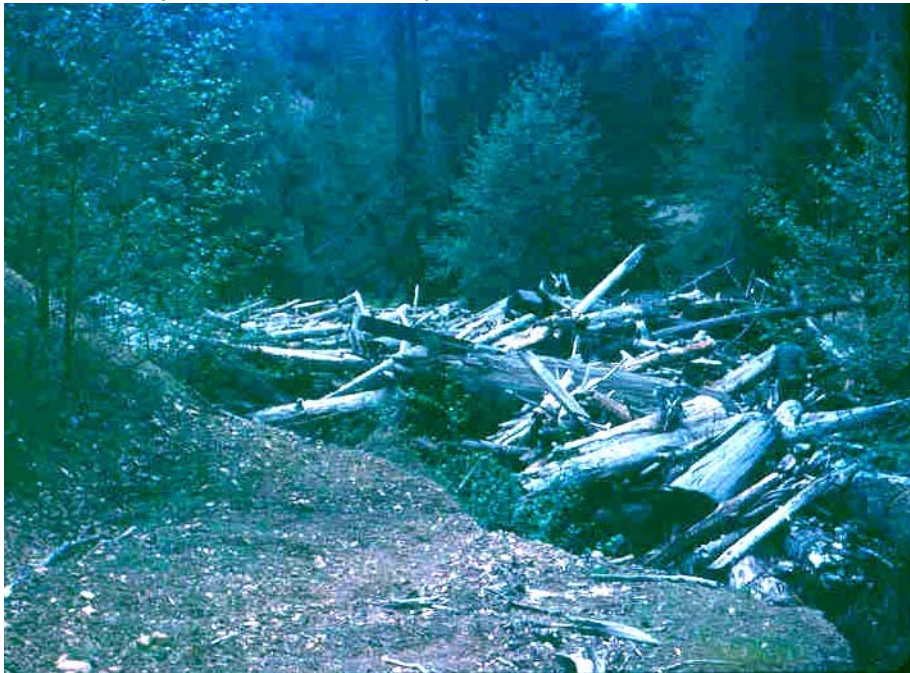
The previous page shows a 1979 photo of a log jam that was about 100 yards long - backed up about 15 feet high at an old-growth Douglas fir log stringer bridge that was used to strip most of the forest after WWII. Ironically, most of the material in the jam was from the trestles and railroad that was completed in 1904 from Bear Harbor to Andersonia on the South Fork Eel River, across from old Piercy. It's a long story that I won't go into here, but the original state-of-the-art bandsaw mill never operated, the old growth logs behind a dam washed to the ocean in a flood in 1928, before the post WWII boom depleted the entire Indian Creek watershed.

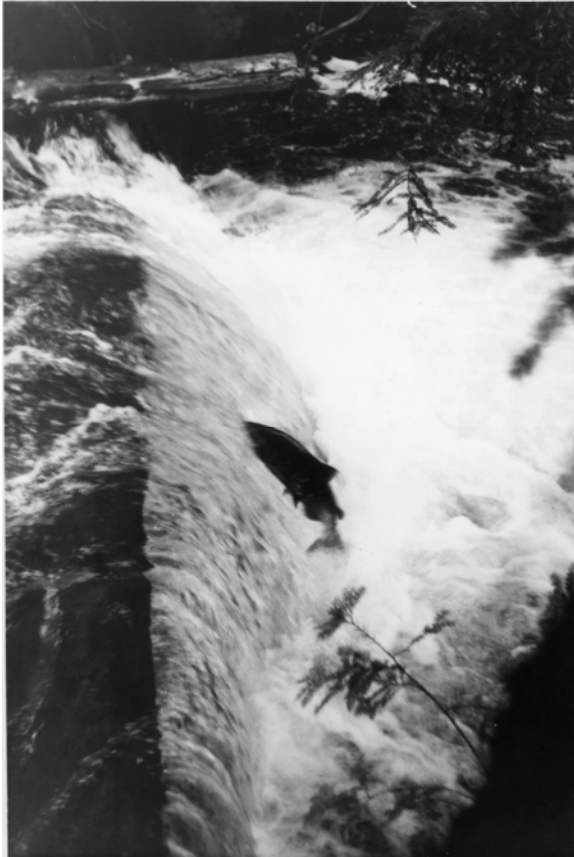
After the jam was modified/removed there were large runs of Chinook Salmon in Indian Creek extending way upstream in Anderson Creek. This photo of a Chinook jumping over a downed Redwood falls, upstream of the jam, was taken in 1980 -- either during the 1979-80 run or the 1980-81 run. Pretty exciting times -- the whole valley stank of salmon carcasses, many piled by bears upslope of the riparian areas, and bald eagles were common with other animals drawn to the run.

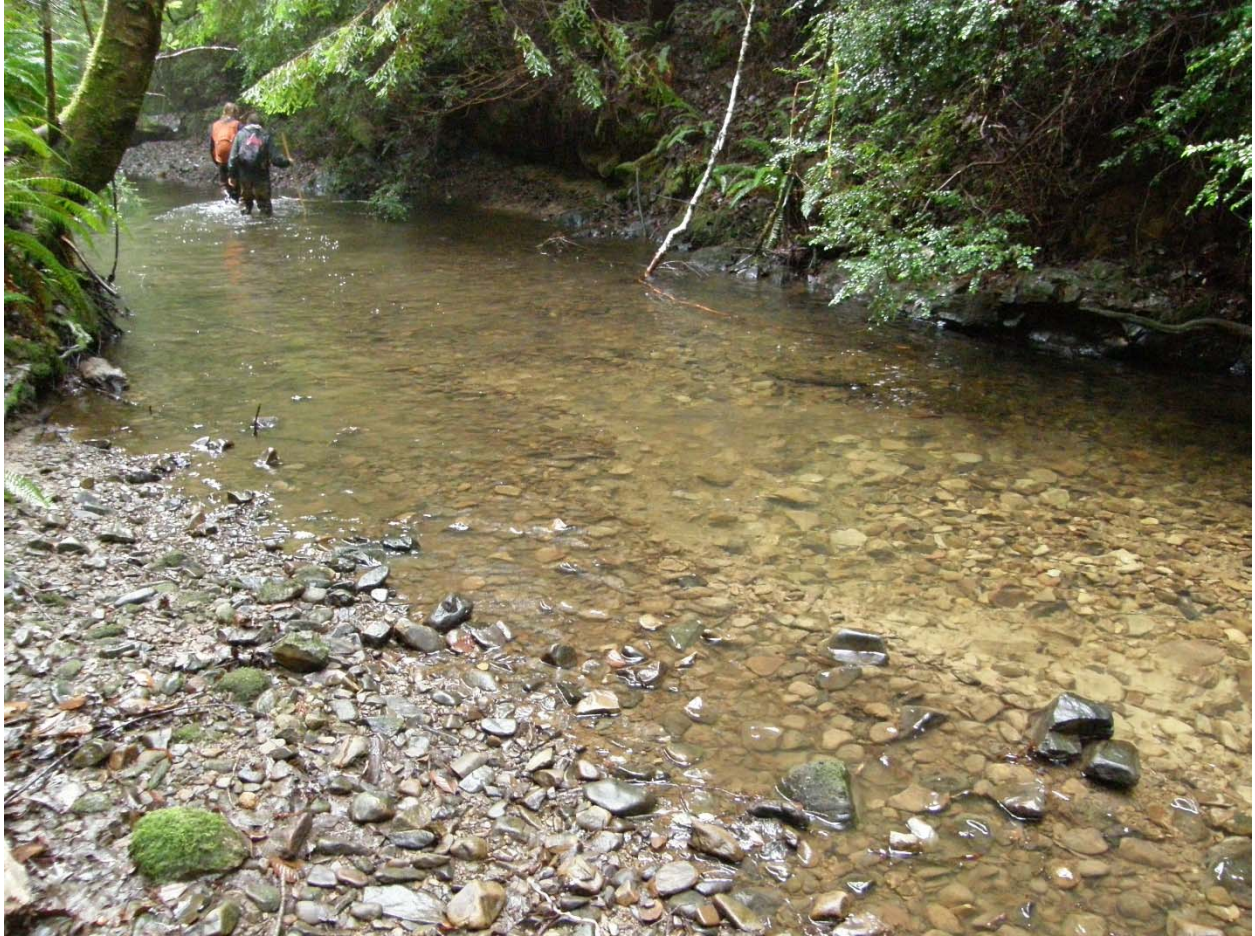
This photo shows renowned restorationists Bill Eastwood and Harry Vaughn during Anderson Creek spawning surveys in 2008 --upstream of a huge Chinook redd (nest) that is in the right of the photo.
